TEMPLE FORD  
DESIGN  
ARCHITECTS

RESIDENTIAL  
PROJECT EXAMPLES

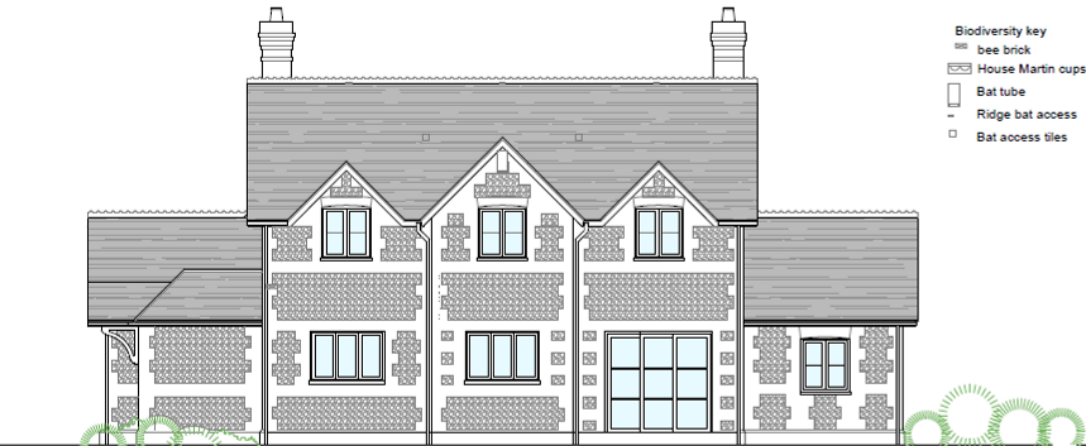
NORTH-WEST ELEVATION

- Biodiversity key
- bee brick
  - House Martin cups
  - Bat tube
  - Ridge bat access
  - Bat access tiles

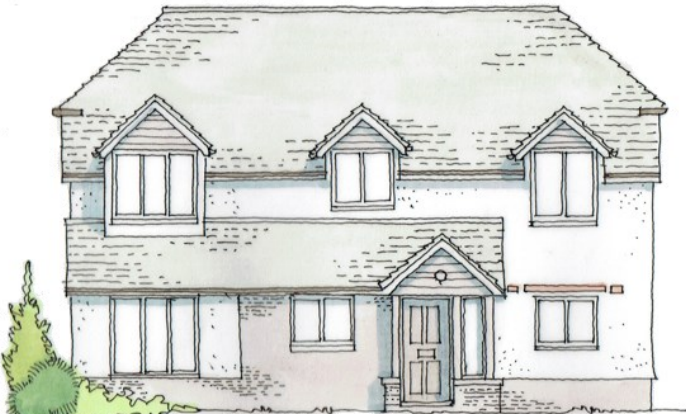
FRONT ELEVATION ~ NORTH

- FINISHES
- ROOF: PLAIN CLAY TILES ~ METAL GLITTER + DOWN-PIPES
  - WALLS: RED MULTI FACING BRICK BASE + THROUGH-COLOUR RENDER
  - WINDOWS: PAINTED TIMBER DOUBLE GLAZED
  - DOORS: PAINTED TIMBER ~ GLAZED
  - PORCH: OAK FRAME - FACING BRICK BASE

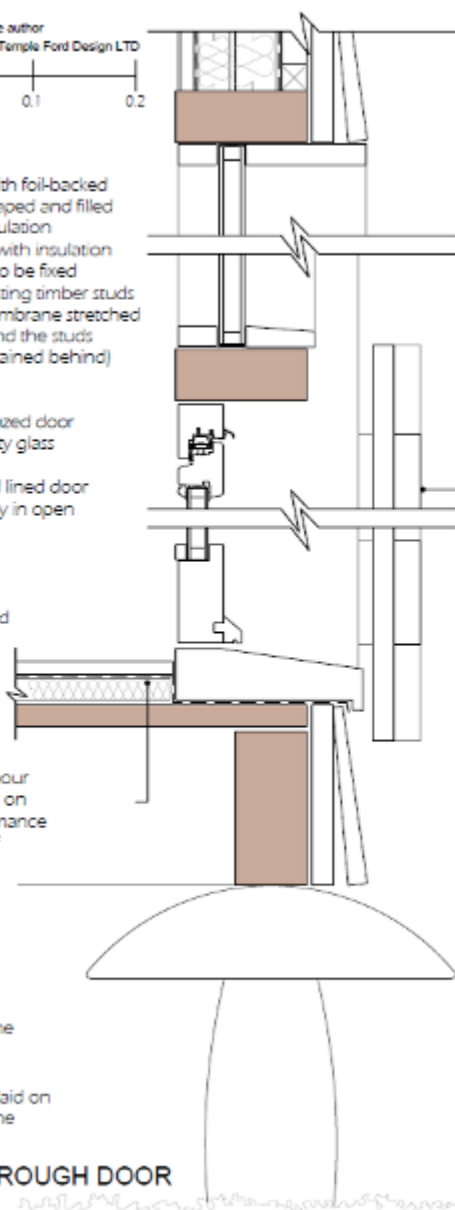
## SECTION THROUGH DOOR

Walls to be lined with foil-backed plasterboard with taped and filled joints on 30mm insulation  
Existing studs filled with insulation  
25x25mm battens to be fixed internally to the existing timber studs with a breather membrane stretched between and around the studs (Airgap to be maintained behind)

New hardwood glazed door  
- Glazing to be safety glass

Existing framed and lined door to be fixed externally in open position

New 175x65mm hardwood threshold

Carpet finish above chipboard with vapour barrier underneath, on 30mm high performance insulation on top of existing floor joists

Existing saddle stone

50mm gravel base laid on geotextile membrane

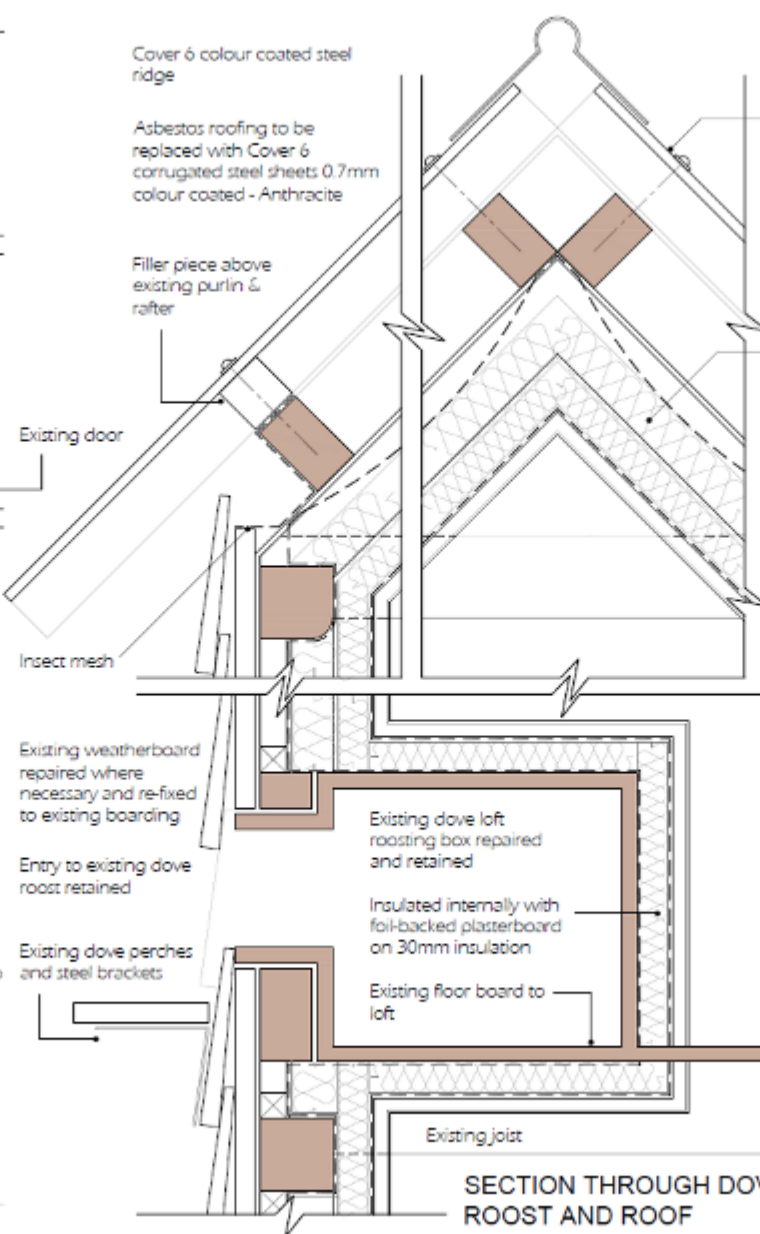
## SECTION THROUGH DOVE ROOST AND ROOF

Cover 6 colour coated steel ridge

Asbestos roofing to be replaced with Cover 6 corrugated steel sheets 0.7mm colour coated - Anthracite

Filler piece above existing purlin & rafter

Existing door

Insect mesh

Existing weatherboard repaired where necessary and re-fixed to existing boarding

Entry to existing dove roost retained

Existing dove perches and steel brackets

Existing joist

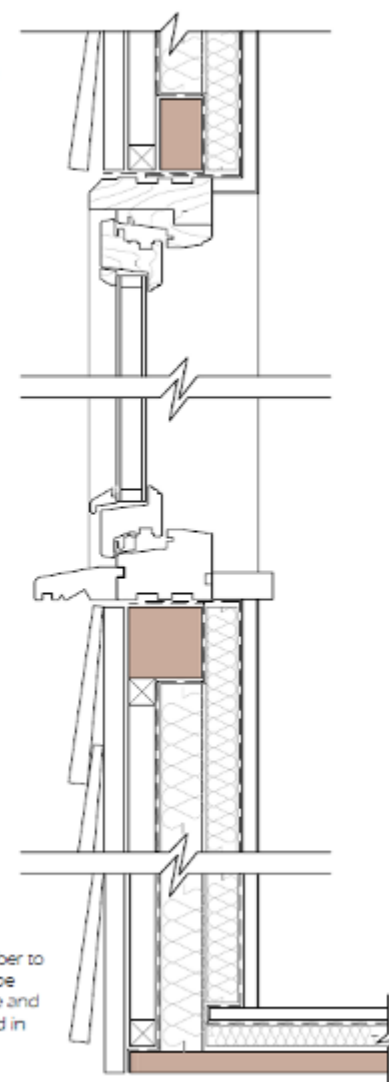
## WINDOW SECTION

New 0.7mm thick colour coated (Anthracite) Cover 6 corrugated steel roofing fixed to existing timber purlins on roof membrane laid to allow cross ventilation

50mm insulation laid between existing rafters and underlined with 30mm insulation and foil backed plasterboard

New stained timber casement windows with slight double glazing. Hardwood sill inset between existing timber studs - 2no. pairs to each gable

Where existing weatherboarding is sound, it is to be re-used. Replacements to match existing

Rotten and decayed timber to be cut away. Timber to be treated with preservative and new timber to be scarfed in
